# fly<sup>ing</sup>

APRIL 1984

# 1984 MISHAP FORECAST

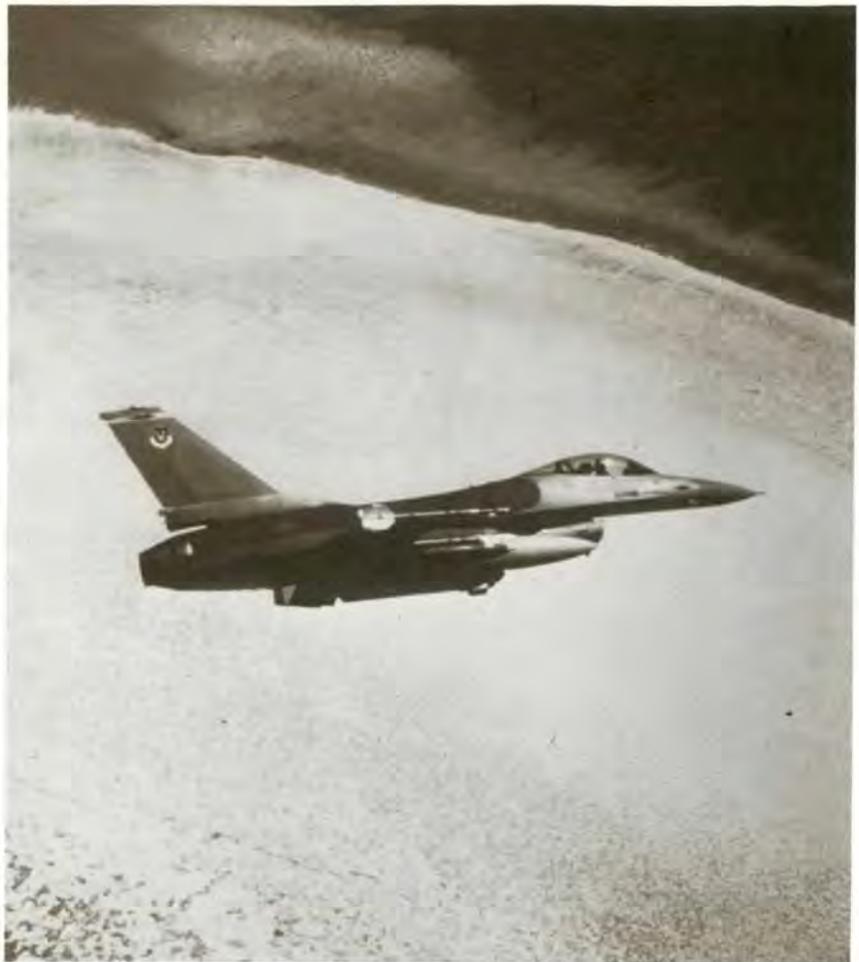
The Quad PMG will provide all F-16s with two on line sources of electrical power. The result will be true dual redundancy in the flight control system.
