fly^{ing} THE HEAVIES

SAFETY

MAY 1984

THE HEAVIES

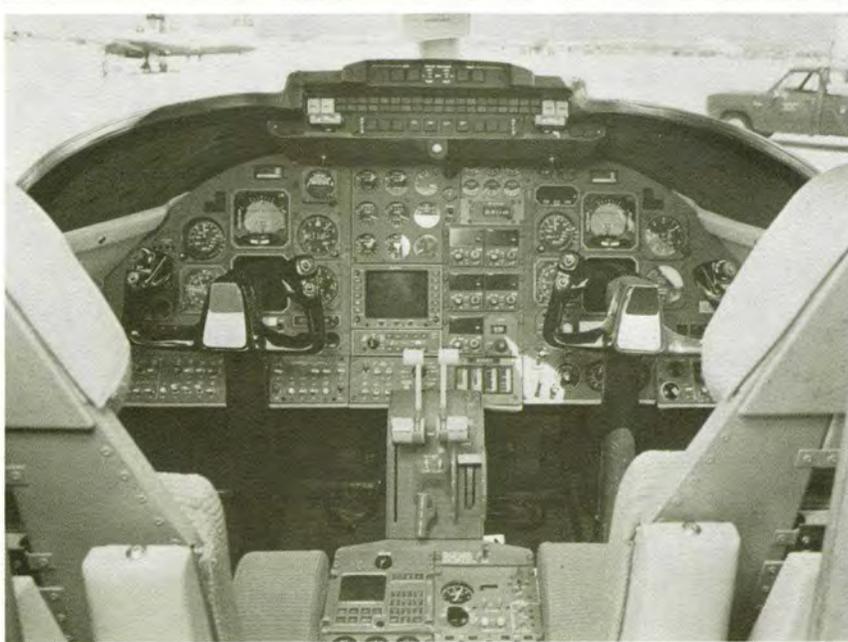
The avionics package supplied with the C-21A includes some of the latest equipment available in the civilian market, including dual flight directors and electronic CRT horizontal situation indicators.

The Learjet model 35 was leased as an off-the-shelf business jet. The avionics package supplied with the C-21A includes some of the latest equipment available in the civilian market. T-39 pilots converting to the C-21A will enjoy equipment such as dual flight directors, including electronic cathode ray tube horizontal situation indicators. Other equipment includes: a standby attitude indicator, dual autopilot capable of coupled approaches, VLF/Omega long-range navigation system, and color weather radar. Many of these features have been sought as Class IVA mods for the T-39 but will be provided in this aircraft as standard equipment. This equipment should enhance the safety of Air Force operations in the C-21A, and that is good news indeed.

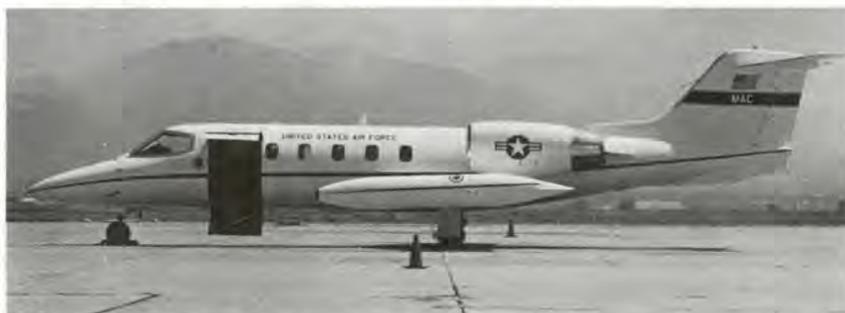
Since its FAA certification in 1974, the Learjet model 35 has built an impressive safety record — a worldwide history of 8 Class A mishaps.
