flying

SAFETY

AUGUST 1984

Lightning and how it affects jet aircraft

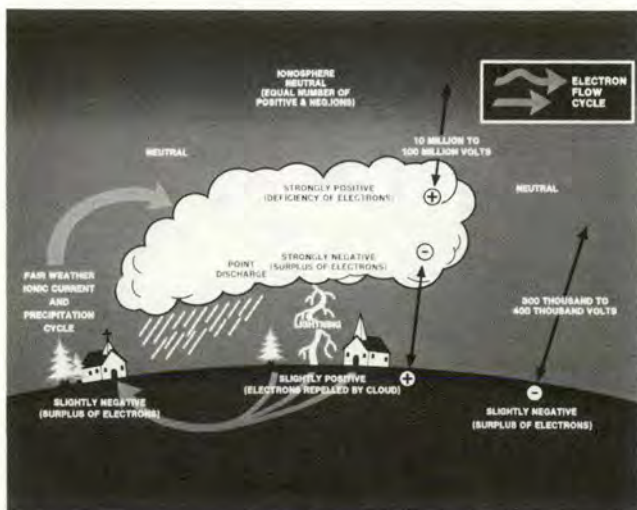
Figure 1 The earth-atmosphere electrical circuit.

■ We live in a world that is actually one big electrical circuit and the switch is always on. Electrical energy is continually flowing from the earth into the air and back to the earth again. Figure 1 shows the closed loop cycle that forms this earth-atmosphere electrical circuit. Moisture evaporating from the earth's surface carries negatively charged ions into the air. This part of the electrical circuit is usually uneventful and unseen. The return of electrons to the earth is never uneventful, being sometimes deafeningly loud, sometimes blindingly bright, and always spectacular; we call it lightning. Some of the various types of lightning discharges which occur are shown in Figure 2.

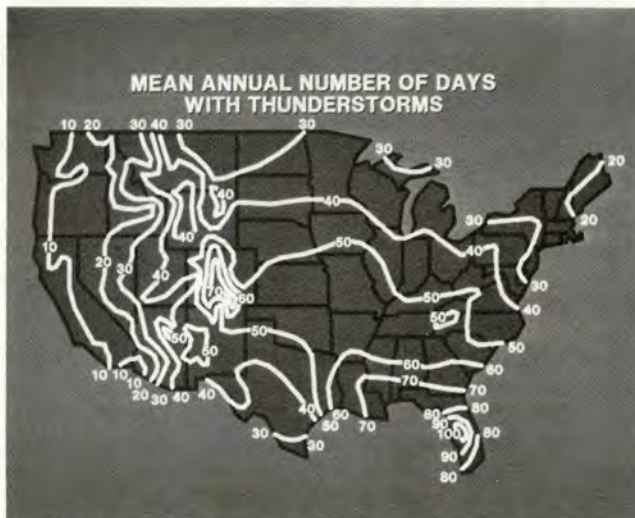
Figure 3 Thunderstorm days (isokeraunic level) within the continental United States as reported by the U.S. Weather Bureau.

The *thunderstorm day*, any day on which at least one clap of thunder was heard, is the only lightning incident related parameter for which large amounts of data exist. If more than one thunderstorm occurred in the same day, it is still recorded as one thunderstorm day. In the event that a thunderstorm occurred one minute before midnight and then the same storm produced thunder at one minute after midnight, two thunderstorm days would be recorded. Hundreds of stations around the world, including ships at sea, have recorded thunderstorm days. Figure 3 is a map developed by the U.S. Weather Bureau which shows the thunderstorm days per year in the continental United States. Average annual world-wide thunderstorm days are mapped in Figure 4.

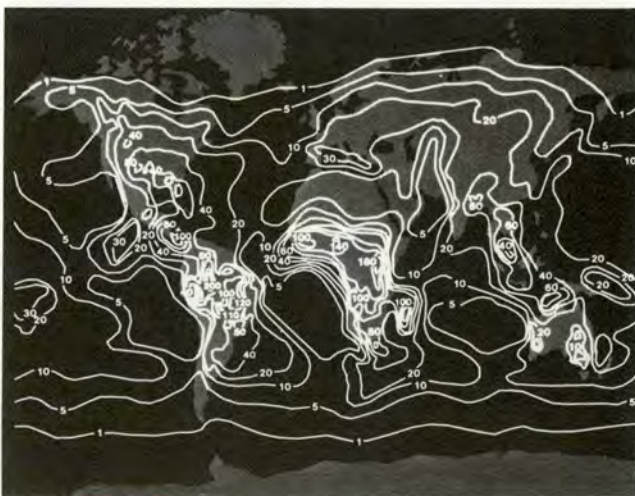
Figure 4 Average annual world-wide thunderstorm days.

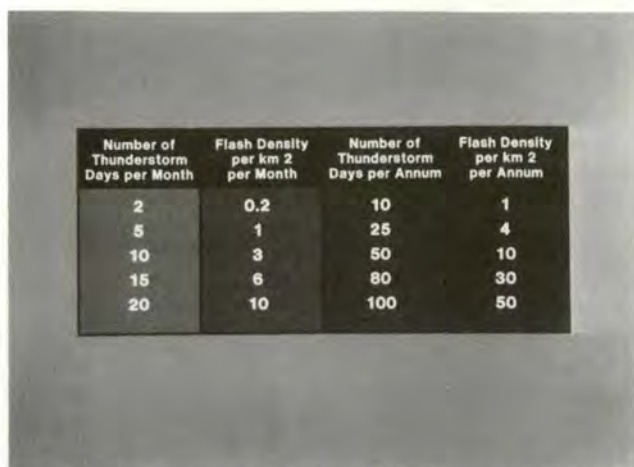
Figure 5 Relationship between thunderstorm days and flash densities.

Through the use of a device known as a lightning-flash counter, data is being collected which will lead to an increasingly accurate connection between lightning flash density and the thunderstorm day parameter. Estimates are that about 100 flashes take place every second over the entire surface of the earth. Cianos and Pierce developed a relationship between thunderstorm days and flash densities (shown in Figure

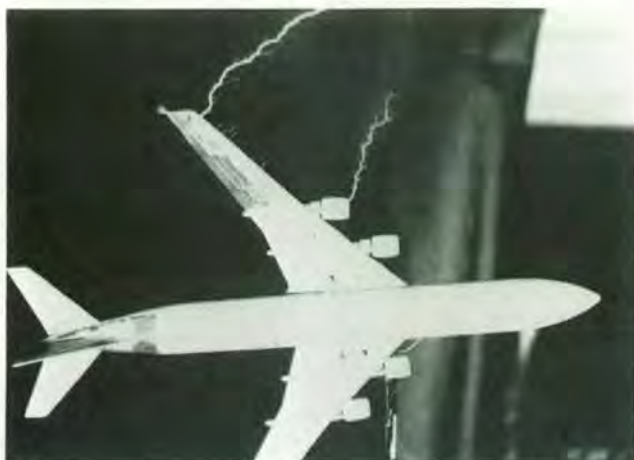
Figure 8A Long arc tests on 747 model show attachment on left wing and streamering from No. 1 nacelle.

Figure 8 is taken from actual long arc attachment tests performed on a 747 scale model aircraft. These and other long arc tests are done to help determine the probable lightning initial attachment points on the aircraft. Notice in Figure 8A that the attachment occurred at the left wing tip and streamering from the outboard engine is present. This is representative of what can happen in flight. Before being struck by lightning, streamers may extend from several points on the aircraft. The advancing lightning stepped leader will connect to one of the streamers which will complete the lightning attachment to the aircraft. A long arc attachment to the model vertical stabilizer is shown in Figure 8B. In this photograph the branching of the stepped leader and streamer can be seen. The streamer branches out as it extends from the aircraft model while the stepped leader branches out as it advances toward the model. This too, is typical of the branching in stepped leaders and streamers in actual lightning strikes.

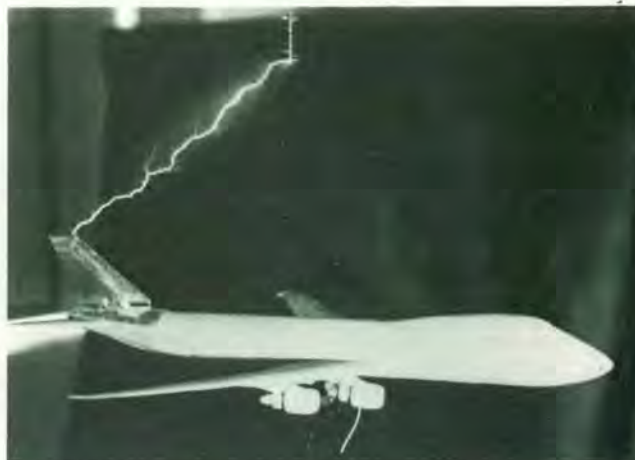
Figure 8B Long arc test on 747 model shows attachment to the vertical stabilizer.

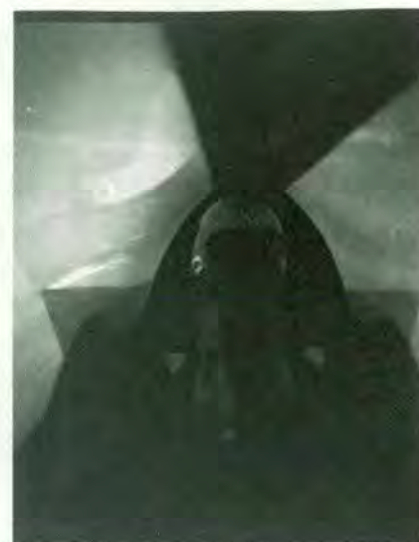
Figure 10 Lightning streamer is shown trailing from the right wingtip of the NASA/Convair F-106B. Light sensing diodes triggered the camera to record this lightning strike at 29,000 feet September 12, 1983.

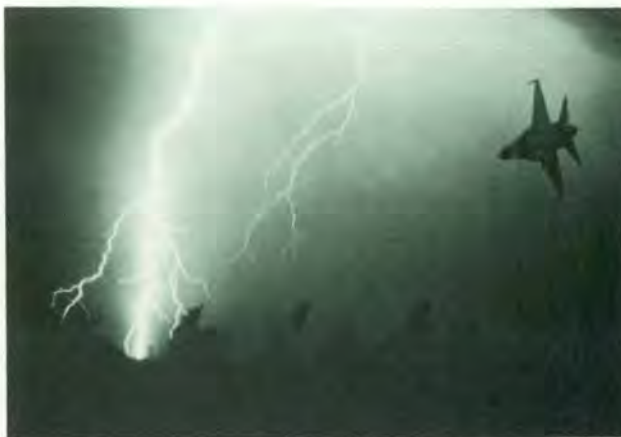
Figure 12

In addition to the direct effects of lightning on aircraft, indirect effects, (transient pulses) produced by the electric and magnetic fields of the lightning current can induce serious transient voltages and currents in the aircraft structure, wiring, hydraulic lines, and electrical or electronic equipment on board.

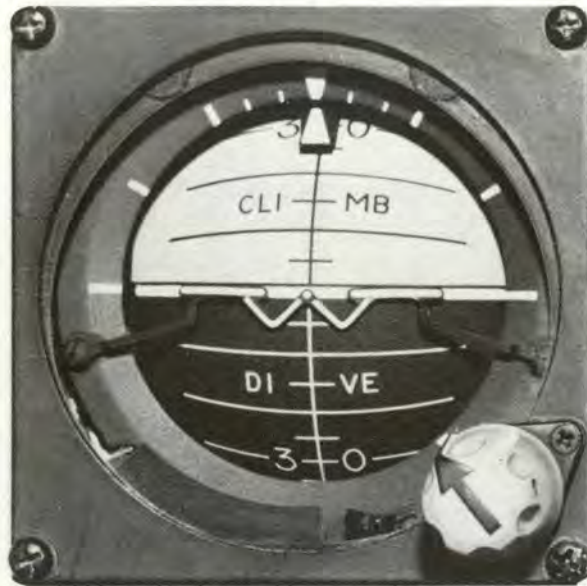
The F-16 SADI is a simple DC powered two axis mil standard gyro that might just save your life.

Fine, you say, great theory, neat stuff for my kid's physics class. But how does it really perform? Well, in practice it is more usable than you may have thought. During 50 BFM missions analyzed at MacDill, it precessed out of its own self-erection capability only about 30 percent of the time. Here is a plot of the results of those 50 BFM missions, with the status of the SADI on beginning RTB. None had been recaged during the flight.

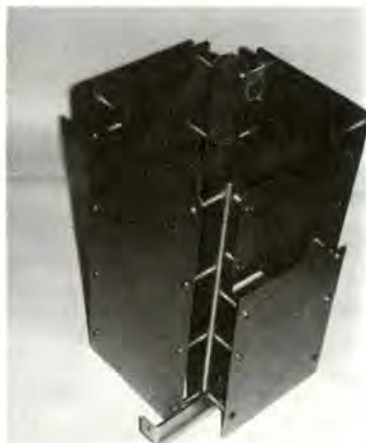
Fuel tank cage for C-130 designed to keep fuel from splashing on the foam during refueling, generating static electricity. This is suspected to be the most common cause of C-130 fuel tank fires. A-10s and C-130s have experienced the most fuel foam fires.

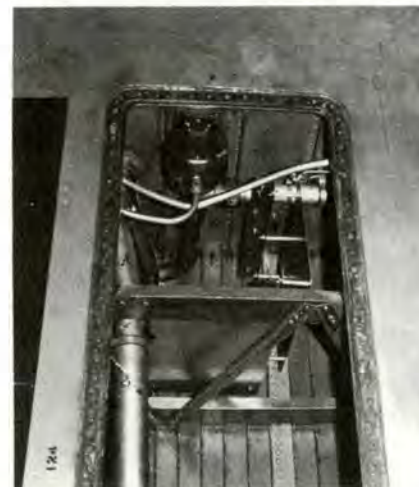
The C-130 fuel tank cage installed. The cage will be surrounded by less conductive yellow foam. The yellow foam deteriorates more rapidly than the blue so it is not effective for the whole tank but does increase separation between the fuel spray and the blue foam.

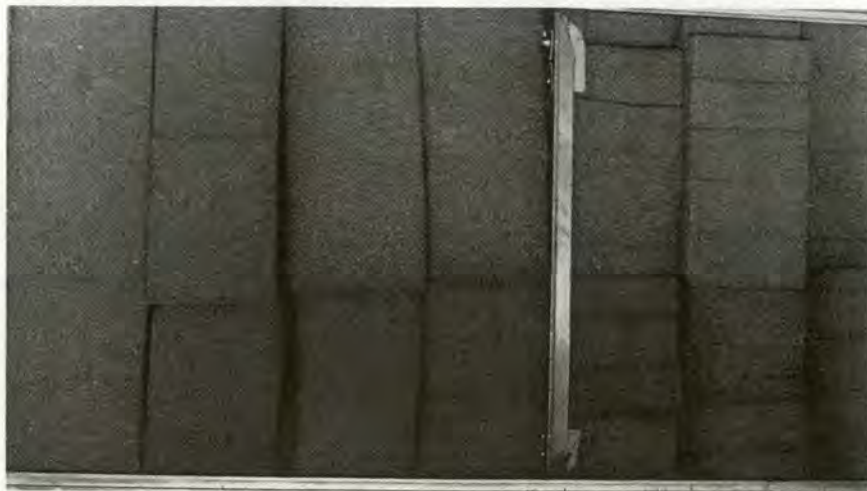
C-130 fuel tank with foam. All the foam must be installed. Removing part of the foam has led to fuel sloshing, static buildup, discharge and explosion.
