fly^{ing}

APRIL 1985

**CLASS A
MISHAPS
1983-1984 —
An Analysis**

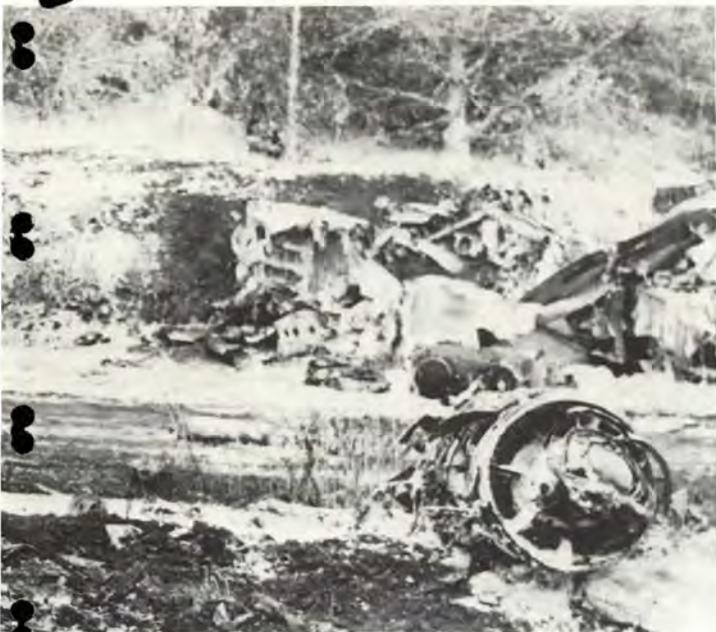
Figure 1

only one since 1982. This decrease testifies to the effectiveness of the automatic maneuvering flap (AMF) and stall inhibitor system (SIS) modifications to those aircraft which were completed in the 1980-82 time frame. The C-135, F-15, C-141, and F-111 total take-off/landing mishaps decreased from 11 to 0 between the two time periods.

During the 1979-82 time period, the reduction in the total Class A mishap rate (Chart 2) was due primarily to a decrease in the operations (pilot factor) rate from 2.04 to 1.01, while the logistics (materiel failure) rate held relatively constant around 1.0. The operations mishap types leading the decrease during this period were control losses, collisions with the ground, and take-off/landing mishaps where the annual mean rates decreased from the .7 and .8 range down to .2 to .3. The differences between 1979-82 and 1983-84 operations rates by mishap type are shown in Figure 1.

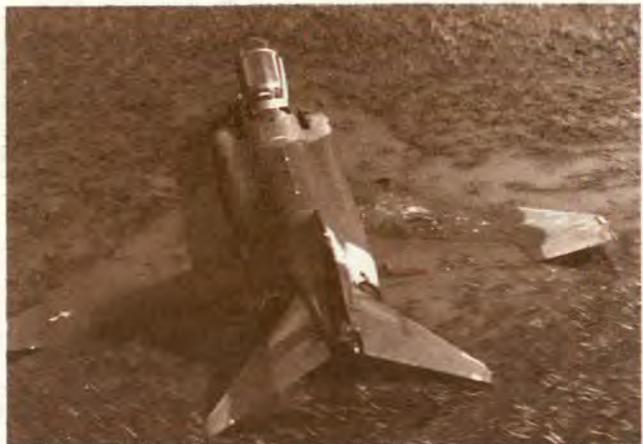
Figure 7
Percent Of Fighter/Attack Population

Total Hours	All Pilots		Mishap Pilots	
	1979-82	1983-84	1979-82	1983-84
0-500	12.2	14.2	12.7	10.9
501-1000	12.0	12.3	15.1	20.0
1001-1500	18.1	15.5	15.9	14.6
1501-2000	17.5	19.1	12.7	20.0
2001-2500	15.3	15.3	29.8	10.9
2501+	25.0	23.7	24.6	23.6

The total fighter/attack pilot population was compared to the operations mishap pilot population over the 1979-82 and 1983-84 time periods, and differences similar to previous studies were identified. Figure 7 shows the total fighter/attack pilot distribution compared to the operations mishap pilots by total flying time.

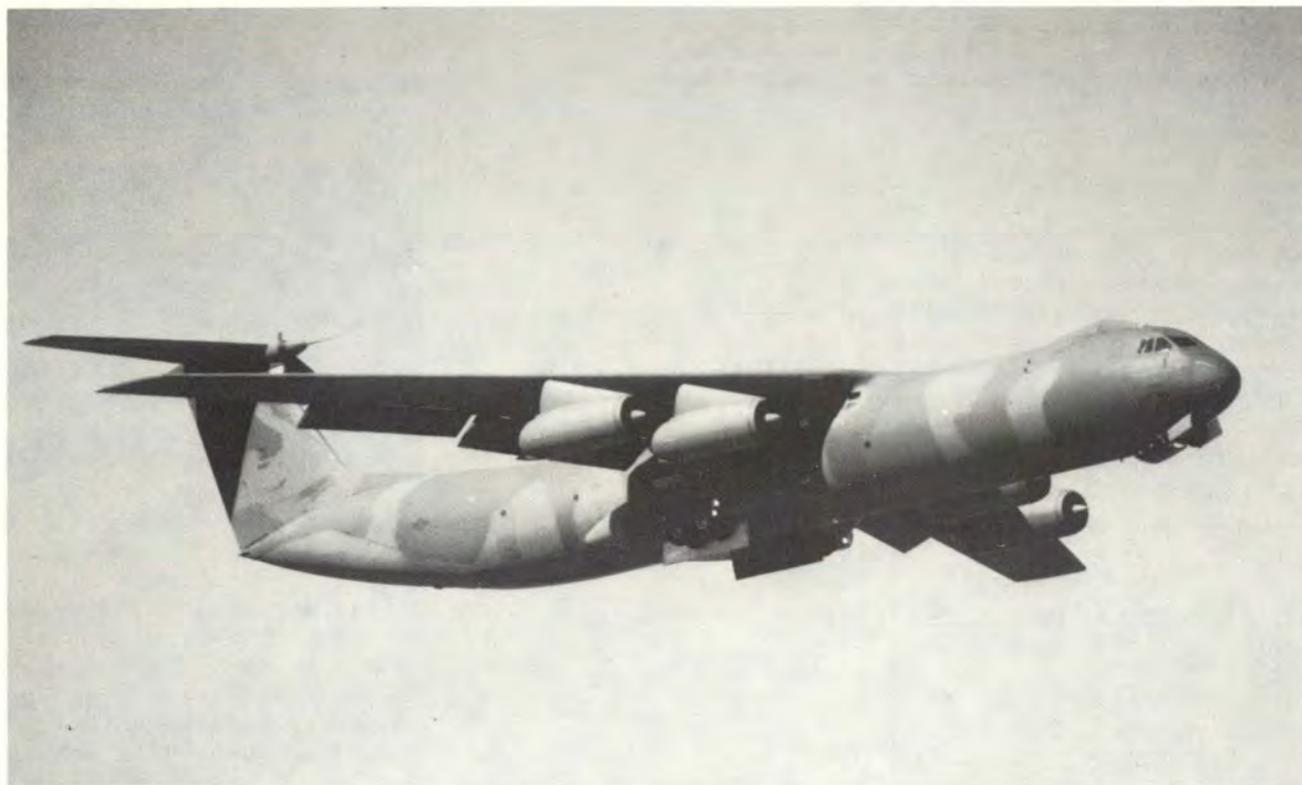
Figure 1
C-141 Flight Mishaps (1979-1984)

A	B	C	HAPs	Total
1979	3	4	90	103	200
1980	1	0	109	123	233
1981	1	1	73	66	141
1982	1	0	66	74	141
1983	0	2	77	73	152
1984	1	0	73	49	123

■ In 1984, the C-141 fleet had good news to cheer about and some bad news to worry about. The good news is that the number of mishaps has decreased from the predictable average of 150 down to a new all-time low of 123 (Figures 1 and 2). The bad news was that this was largely due to a change in mishap reporting requirements. Additionally, after an impeccable 1983 with no Class A mishaps, 1 C-141 and its crew crashed shortly after takeoff, fatally injuring all on board. In the meantime, the C-141 continues its unquestionably unsurpassed leading role as the strategic/tactical airlifter of the year — a plane for all seasons.
