flying

APRIL 1986

Mishap Review
and Forecast

THE HEAVIES

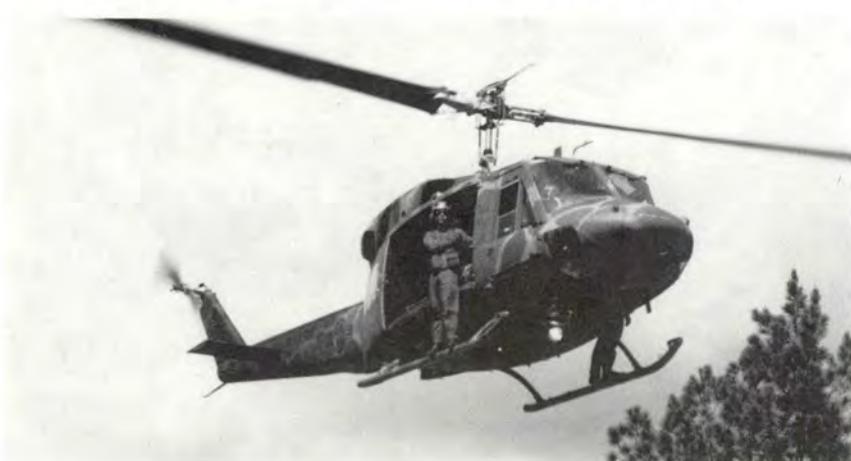
Figure 2
HAP and Class C Mishaps

H-1	H-3	H-53	H-60
Rotor System	2	0	1	0
Fit Controls	2	2	3	0
Engines	15	6	8	2
Drive System	8	3	2	0
Fuel System	2	0	2	0
Aircrew	3	1	3	1
FOD	1	4	0	0
Misc	8	9	3	2
Total	41	25	22	5

The total number of HAP and Class C mishaps remained the same as 1984. This year, we experienced 41 HAP and 52 Class C mishaps. Figure 2 breaks these mishaps down further.
