# 40 flying

FEBRUARY 1988

**SPECIAL ISSUE**

**Mishap Review and  
1988 Forecast —  
Ejection Summary**

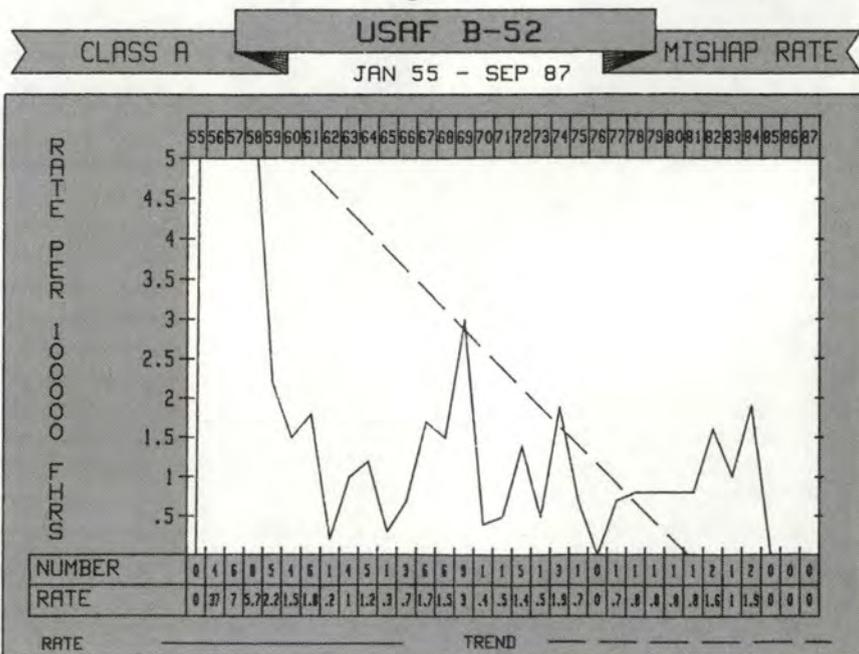
The "Buff" has amassed approximately 6,637,642 flying hours; 79,415 of those hours being flown last year. Figure 1 shows which years the 90 Class A mishaps occurred. These mishaps resulted in the loss of 307 lives and 71 destroyed aircraft. The B-52's mishap rate for 1987 was a big zero as compared to the Air Force's 1987 rate of 1.51. This article will address the B-52's recent mishap experience, trends, current actions, and modifications.

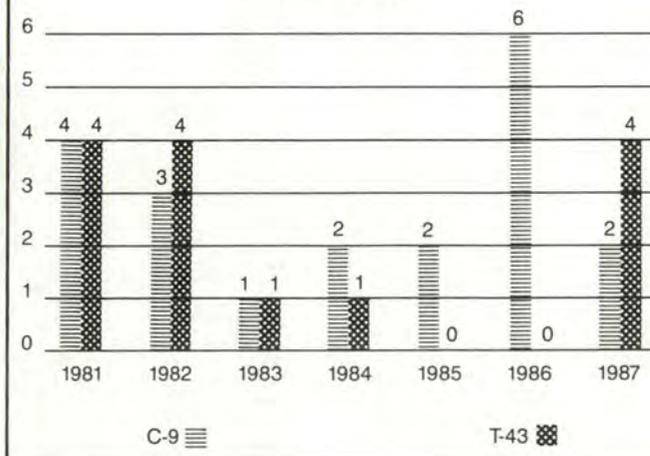
**Figure 4**  
Engine Failure Comparison  
(T-43 vs C-9)

While the C-9 fleet has consistently experienced more engine-related problems with their Pratt & Whitney JT-8D engines, the T-43 fleet dominated this area in the first 9 months of 1987 (Figure 4). As shown in Figure 4, the T-43 fleet experienced four engine failures and

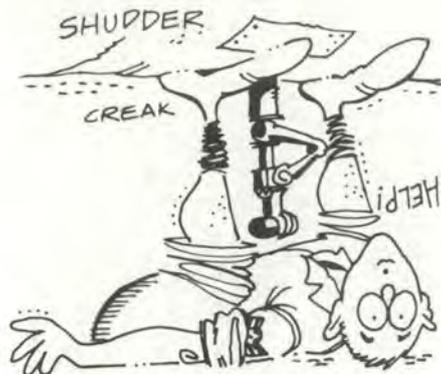
## JACK AND JILL WENT UP THE HILL, BUT ONLY JACK CAME DOWN

■ Following the first mission of the day, the crew chief found his F-4 needed a main tire change. He removed the worn tire and wheel without any problems. But when he went to install the new wheel and tire, the tread of the new tire dragged against the ramp, making it difficult to push the wheel into the brake head.

When this unit submitted a materiel deficiency report (MDR) to determine the cause of the jack failure, they found there had been three other MDRs on the same type of jack. In fact, the unit's telephone conversations with the project technician revealed that part number (PN) 4920 represents the oldest 15-ton jacks in use.

A replacement jack (PN 8925) had already been identified, but early production problems resulted in a mass recall. The aging 4920 jacks are being replaced by attrition, but only as replacements become available.

Meanwhile, since the 4920 15-ton jacks are prone to fractures in the base plate, perhaps units still using these items may want to increase their inspection intervals to prevent another failure on the flightline.

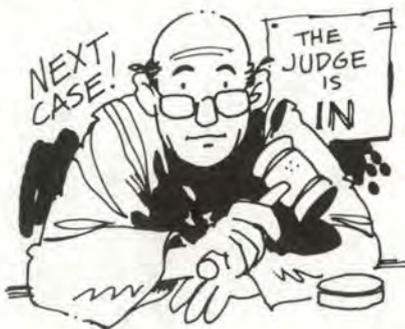
## T-37: LAW OF LAST CHANCE

An aero repair (AR) technician was dispatched to a T-37 to install and rig the canopy actuator. The left seat was removed for maintenance, and all lines were disconnected and safety pins installed.

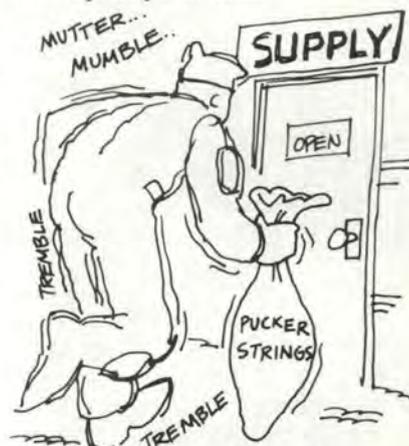
## HAIR RAISING TAKEOFF

As the copilot advanced the throttles on a multi-engine aircraft during takeoff, he noticed the No. 2 engine pressure ratio (EPR) indicated 2.10, instead of the normal 2.01 with 94 percent RPM. When he pulled the No. 2 throttle back, the EPR stayed at 2.10.

ed from the crossover shaft. The castellated nut on the bolt connecting the thrust rod and crossover shaft had completely backed off, allowing the bolt to fall out and the thrust rod to disconnect. The castellated nut, bolt, and washer were in the cowling, but a cotter pin that secures the castellated nut was not found.

Maintenance actions included removing, relubing, and reinstalling the throttle friction brake assembly, followed by a throttle rig. However, investigators found the throttle rigs in the unit were not being performed in accordance with the technical orders. Because there was no formal training or certification required for technicians performing throttle rigs, an incorrect "word-of-mouth" procedure had been passed along.

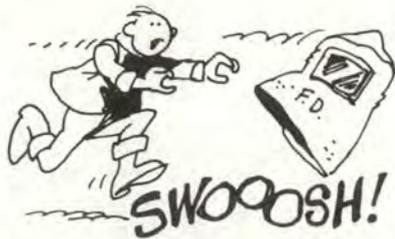
## OA-37B: HOOD HAZARD

Immediately following the "Dragonfly" landing, a firefighter walked up to the right side of the aircraft carrying the hood to his firesuit in his hand. As he approached the cockpit, his hood was sucked up against the right engine screen.
