flying

FEBRUARY 1989

SPECIAL ISSUE
1988 MISHAP
REVIEW

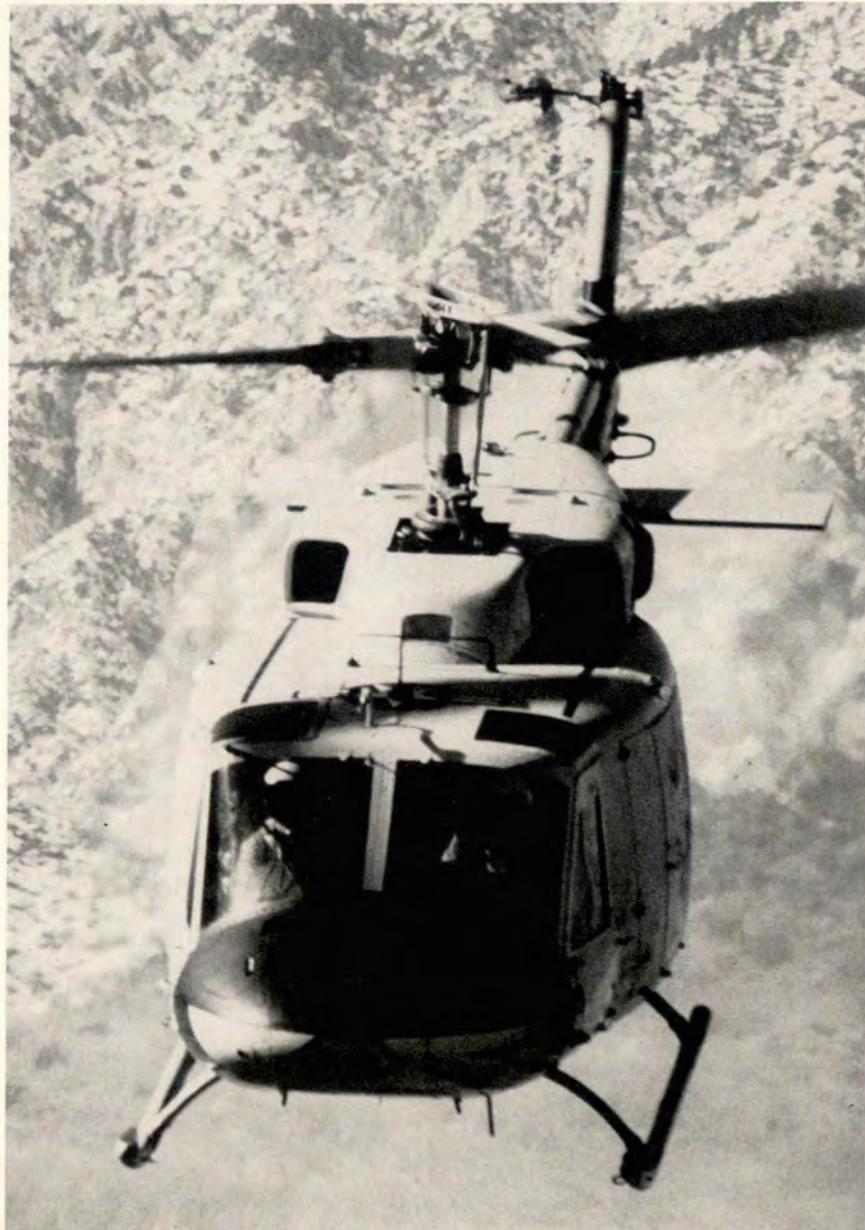
Figure 5 shows engine mishaps accounted for almost 40 percent of the total number experienced, and this percentage is somewhat higher than in previous years. Of the 28 engine mishaps reported, 12 were flameouts (5 during flight), and 11 were shutdowns (7 during flight). Half of these were caused by material failure of some portion of the engine. The remainder were caused

by a number of things, including throttle rigging, loose fittings, missing seals, and chip lights.

Figure 5 Mishap Breakdown			
	H-1	H-3	H-53	H-60
Engines	11	8	9	0
Fuel	3	0	0	0
Rotor	3	1	2	0
Drive	1	2	2	0
Flt Cont	0	3	1	0
FOD	4	1	1	0
Aircrew	1	2	2	1
Misc	1	6	6	0
Total	24	23	23	1

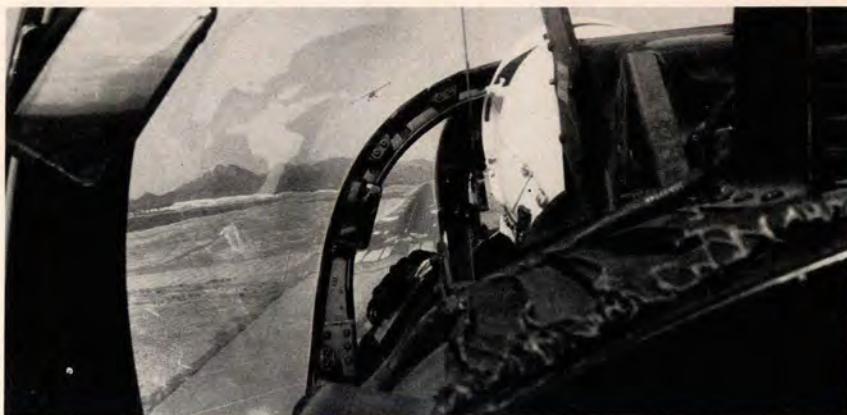
When a HATR investigation is completed and the final report is sent to AFISC, the incident is assigned a "classification" by AFISC's Air Traffic Control Branch (SEFA). It is then encoded and entered into the automated data file. The General HATR Classification chart shows the individual classifications and includes NMAC and N-NMAC.
