CONTENTS

# Bombers

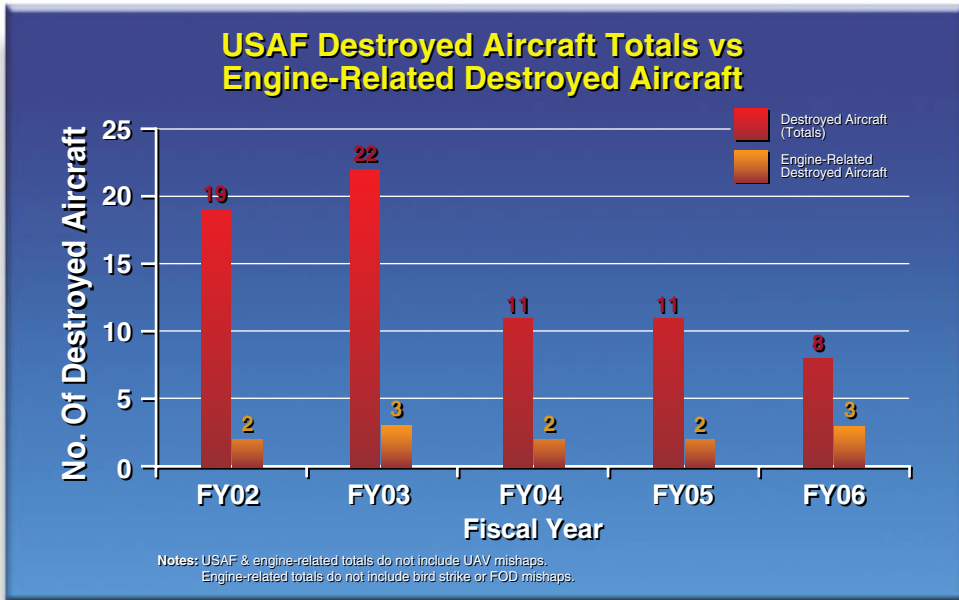
Figure 1

To show these three destroyed aircraft in the context of the last five years, we present Figure 1. The two bars for each fiscal year represent the total number of destroyed aircraft (left) and the number of engine-related destroyed aircraft as a subset of the total (right). Engine-related loss of aircraft has remained steady at two or three per year while the overall total has dropped dramatically over the depicted five-year timespan. An encouraging change from FY04 and FY05 was the absence of operations and maintenance-induced engine failures this year. Now, the engineers are really feeling the pressure to improve!

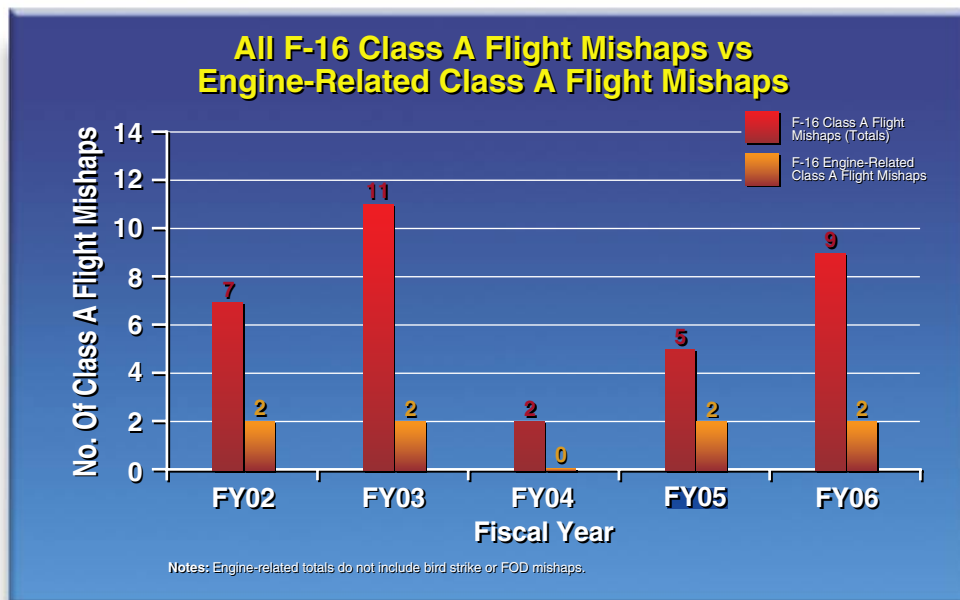
Following a terrible FY01, during which we lost seven F-16s due to engine malfunctions, the last five years have stabilized at about two losses per year. FY06 reinforced that average. Table 2 conveys this point in a numeric format, including associated rates. Table 2 and Figure 3 show that we are now two years removed from having achieved our airframe-specific goal of zero engine-related destroyed F-16s. Knowing that F-16 losses have traditionally dominated this category, FY04 should boost our resolve to achieve a broader goal—zero engine-related destroyed aircraft of any type! Be an expert, be dedicated, be vigilant!
